Executive Summary

On Wednesday, October 23, 2024, four Delaware firefighters were injured while battling a residential structure fire in Wilmington, Delaware. At 5:04:34 PM, the New Castle County Fireboard dispatched Elsmere Fire Company along with mutual aid fire companies to a residential structure fire located at 113 S. Colonial Avenue Wilmington, Delaware. The responding companies included Elsmere, Cranston Heights, Belvedere, Mill Creek, Five Points, Minquas, and the Wilmington Fire Department. Ladder 17

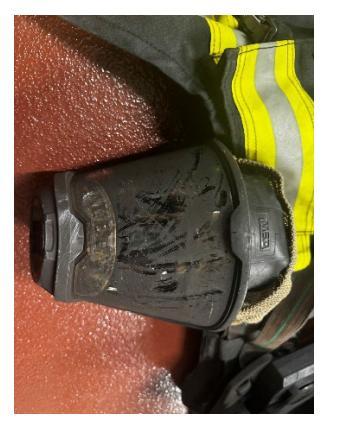
Image 9 – SCBA Face Piece

The SCBA worn by the Wilmington firefighter showed thermal damage in several areas, including both right and left shoulder straps, the cylinder guard, the carrier, the hose tether, the shoulder strap pull, and the cylinder gauge. Additionally, the PPE assigned to the firefighters from the Five Points Fire Company, along with their SCBA, was sent to the distributors for thorough inspection. The inspection report is attached for your review.
