Delaware State Fire Commission

F.I.R.E. TEAM Incident Report

Executive Summary

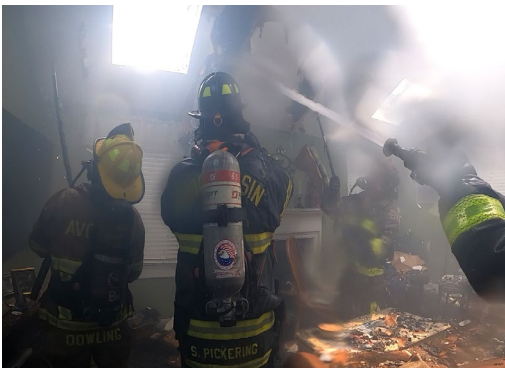
PH-10 Helmet View of Ceiling Collapsing

- *Burn Time – Fire load weakens structural members along with a large amount of water being applied will cause weakened framing.*
- *Situational awareness as related to expected building performance under fire conditions.*
- *Lack of Safety Officer*

International Fire Service Training Association (IFSTA) 7th Edition Chapter 15 Overhaul Procedures instructs the firefighter not to stand directly under the area to be opened. The overhaul procedures chapter also highlights safety as being the first consideration of overhaul. When pulling ceilings from the underside of fire-damaged floor joists firefighters should recognize and prepare for the possible collapse of the floor joist above. This is highlighted in the Delaware State Fire School Structural Fire Fighting training program.

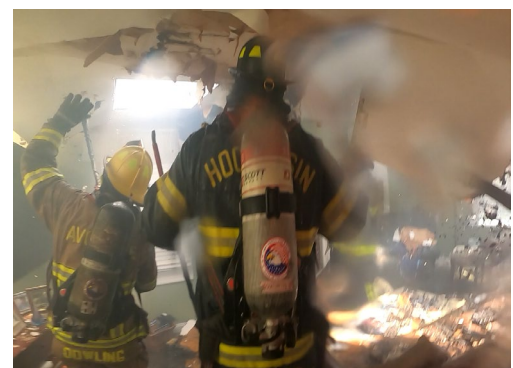
PH-11 Helmet View of Ceiling Collapsing

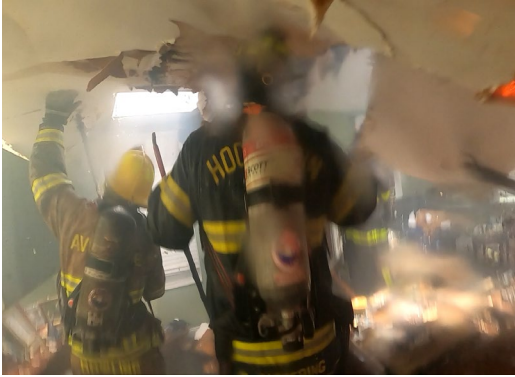
PH-12 Ceiling Collapsing Upon Injured FF Ceiling

- *Fire departments should ensure that a safety officer, independent from the incident commander, is appointed at working structure fires. (NFPA 1561, 8.13.1 and 8.13.2)*
- *Fire departments should ensure that firefighters are trained in situational awareness as related to expected building performance under fire conditions. (IFSTA 7th edition, Chapter 4, Fire Dynamics) NFPA 1001, 4.3.10, and 4.3.11)*

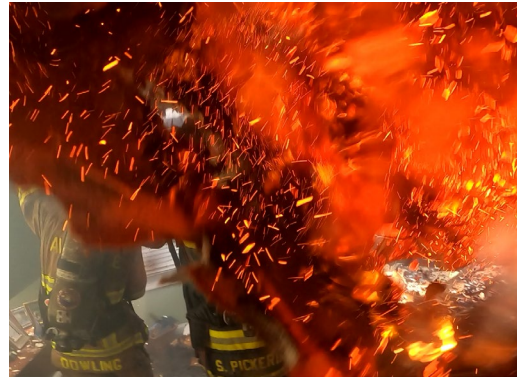
PH-13 Complete Collapse of

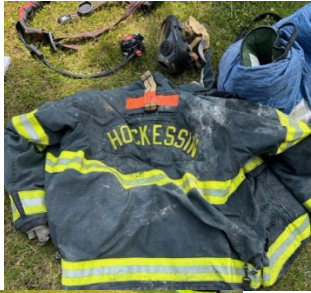
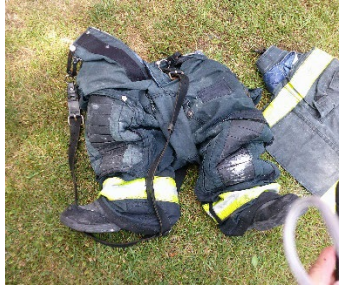
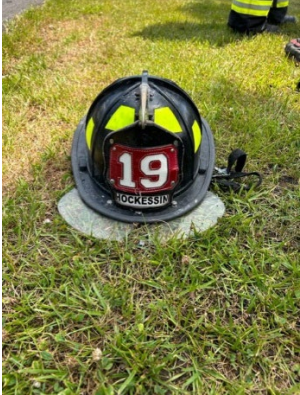
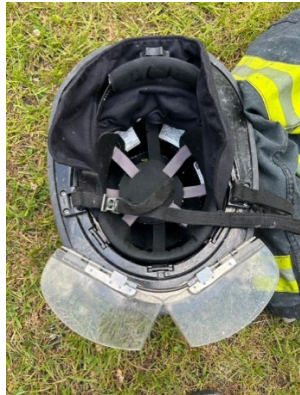
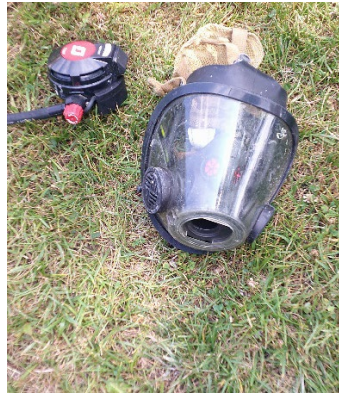
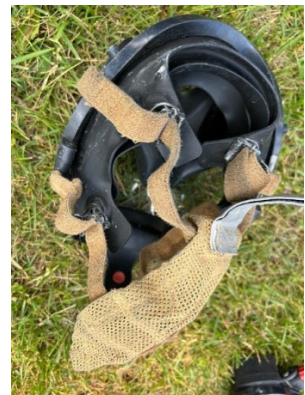
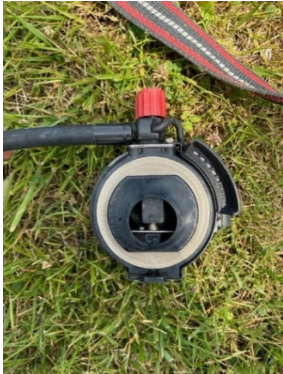
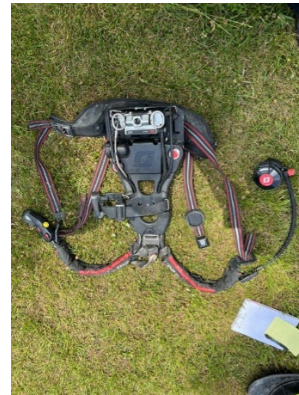
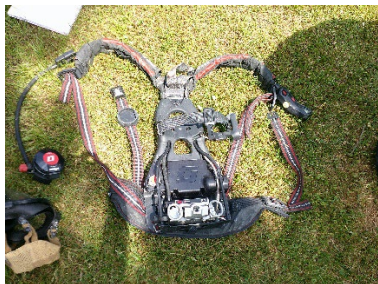
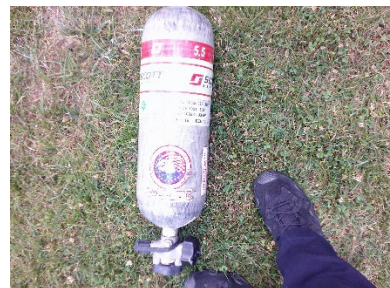
The National Fire Protection Association (NFPA) 1971 plays a crucial role in safeguarding firefighting personnel by setting established minimum levels of protection against various hazards they face, including thermal, physical, environmental, and bloodborne pathogens, particularly during structural and proximity firefighting operations. Essential standards outlined in this regulation cover vital personal protective equipment (PPE), including helmets, gloves, boots, turnout coats and pants, and self-contained breathing apparatus (SCBA). It is important to note that both injured firefighters were equipped with all required personal protective gear at the time of the incident. Upon thorough inspection, the gear belonging to the Hockessin firefighter was confirmed to be compliant with NFPA 1851 standards, underscoring the

significance of adhering to these safety protocols to ensure the well-being of firefighting personnel in the line of duty.
